2 LAKE KIMBERLY DAM

3 NDI NO. PA-00949

PHASE I INSPECTION REPORT

NATIONAL DAM INSPECTION PROGRAM

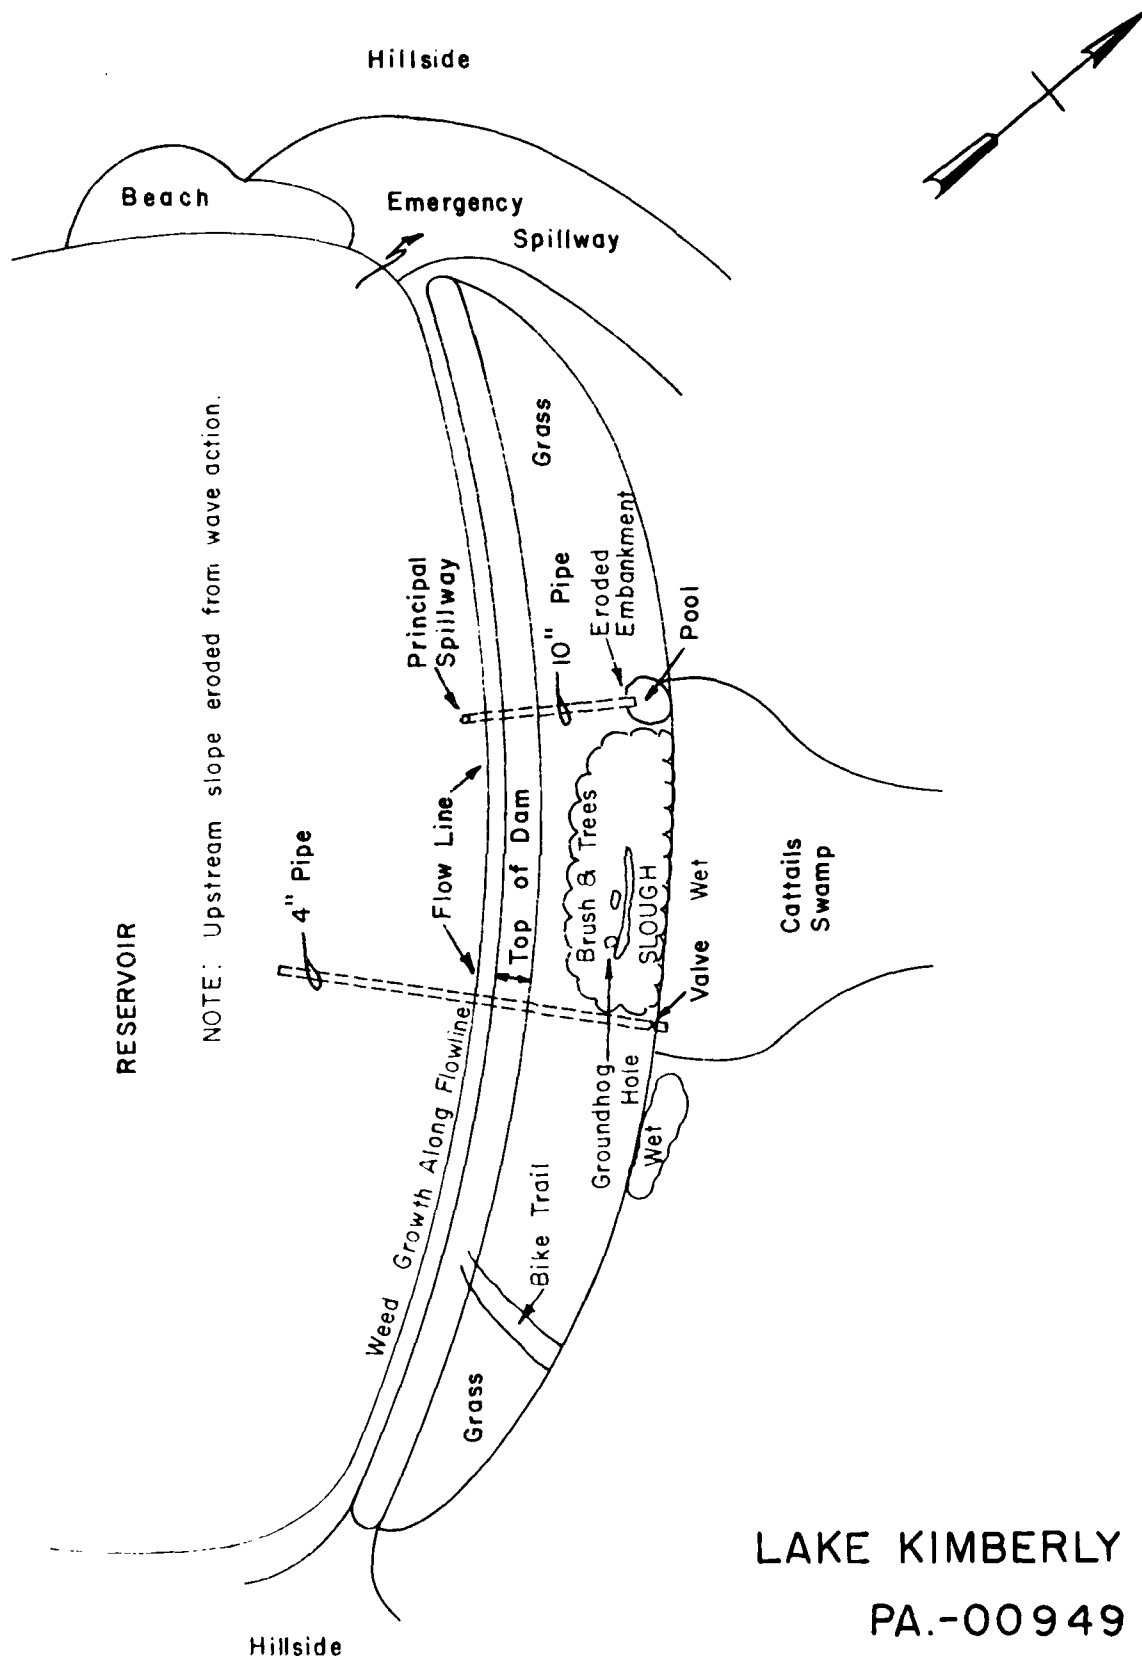
PLATE A-I

Records of operation are not maintained by the owner. Within one or two weeks after construction was completed, a slough occurred on the downstream slope in the area indicated on Plate A-I. This condition has not been improved nor repaired.

B. UNUSUAL MOVEMENT BEYOND TOE	One area has been displaced forming a bench on the downstream slope.
C. SLOUGHING OR EROSION OF EMBANKMENT OR ABUTMENT SLOPES	A major slough or slope failure is evident on the downstream slope. Refer to cross section. Erosion is occurring due to wave action on the upstream slope. Groundhog hole located in slumped area.

NOTE: Upstream slope eroded from wave action.

4. That the slough on the downstream slope be repaired and reseeded under the direction of an engineer experienced in the design and construction of dams.

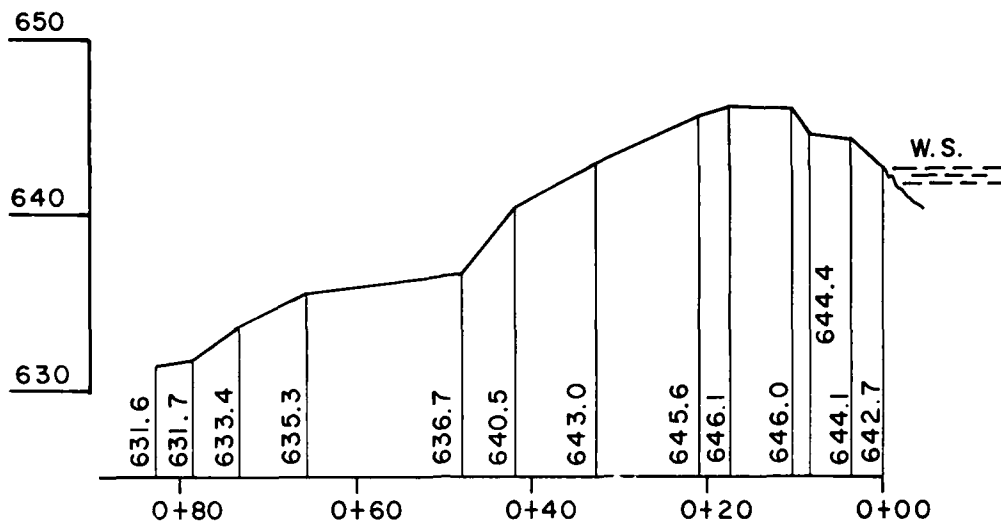
A large slough and heave occurred shortly after construction was completed. The owner stated that no further movement has occurred since that time. Information indicating the cause of this slide is not available. Heavy growth of briar prevented close observation. The erosion of the downstream slope at the outlet of the 10-inch discharge pipe should be repaired. Wave action is receding the upstream slope. The crest of the dam has an irregular profile.

EMBANKMENT SECTION STA. 3+20
IN AREA OF SLIDE

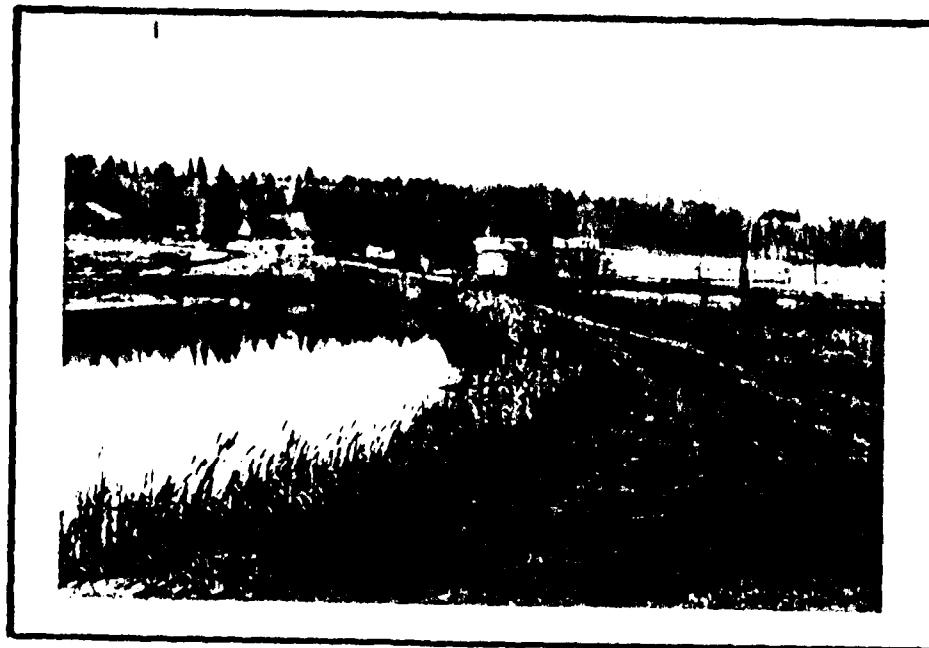
CATTAILS ON UPSTREAM SLOPE - NO. 5

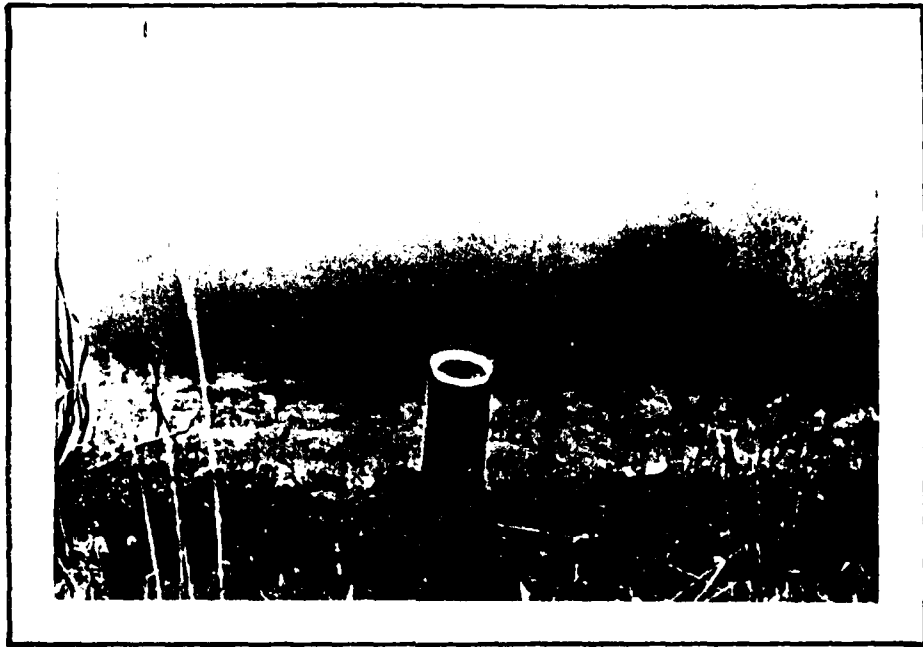
The principal spillway is an 8-inch drop inlet pipe located on the upstream slope. The 8-inch diameter pipe was obstructed with a plastic container. This obstruction should be removed. This vertical pipe is connected to a 10-inch horizontal discharge pipe which discharges above the downstream toe in a small eroded plunge pool (Photograph No. 7). The embankment at this location has been eroded to a near vertical slope. It appears that a section of the pipe has been broken off.

8-INCH OUTLET PIPE - NO. 6
